STM32F411xC/xE device errata

This document applies to the part numbers of STM32F411xC/xE devices and the device variants as stated in this page.

It gives a summary and a description of the device errata, with respect to the device datasheet and reference manual RM0383.

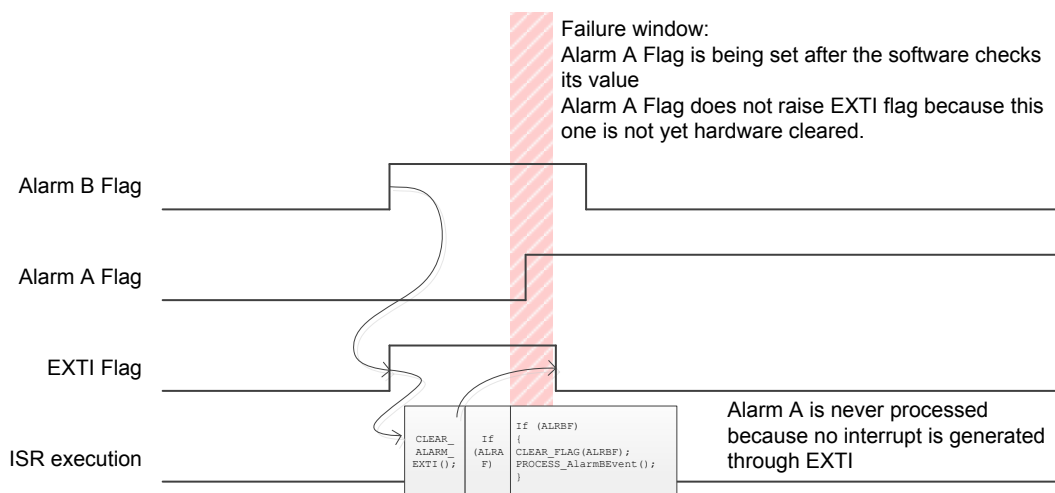
Figure 1. Masked RTC interrupt

The following code example and figure illustrate the failure mechanism: The Alarm A event is lost (fails to generate interrupt) as it occurs in the failure window, that is, after checking the Alarm A event flag but before the effective clear of the EXTI interrupt flag by hardware. The effective clear of the EXTI interrupt flag is delayed with respect to the software instruction to clear it.
