STM32L431xx/432xx/433xx/442xx/443xx device errata

This document applies to the part numbers of STM32L431xx/432xx/433xx/442xx/443xx devices and the device variants as stated in this page.

It gives a summary and a description of the device errata, with respect to the device datasheet and reference manual RM0394.

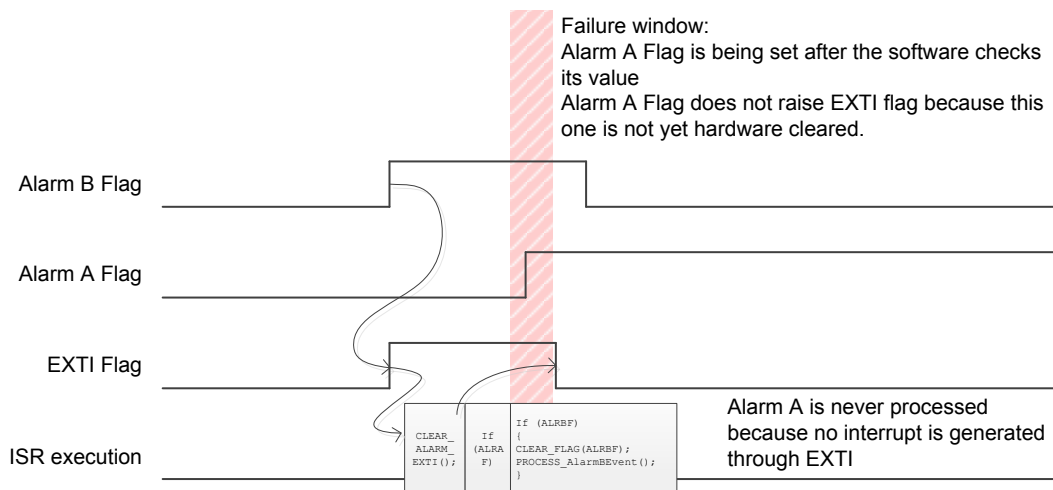
Figure 2. Masked RTC interrupt

The following code example and figure illustrate the failure mechanism: The Alarm A event is lost (fails to generate interrupt) as it occurs in the failure window, that is, after checking the Alarm A event flag but before the effective clear of the EXTI interrupt flag by hardware. The effective clear of the EXTI interrupt flag is delayed with respect to the software instruction to clear it.
