## STM32L151x6/8/B-A and STM32L152x6/8/B-A device errata

This document applies to the part numbers of STM32L151x6/8/B-A and STM32L152x6/8/B-A devices and the device variants as stated in this page.

It gives a summary and a description of the device errata, with respect to the device datasheet and reference manual RM0038.

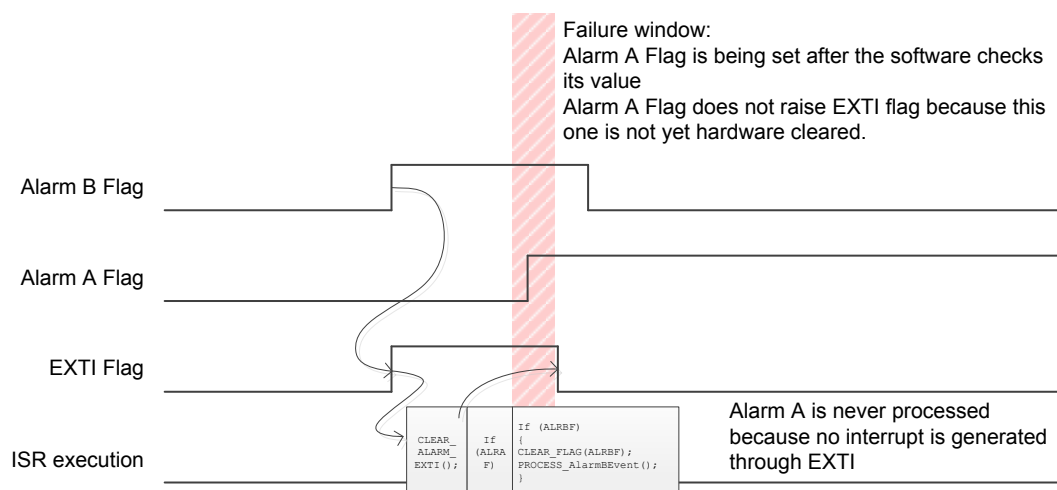
**Figure 1. Masked RTC interrupt**

The following code example and figure illustrate the failure mechanism: The Alarm A event is lost (fails to generate interrupt) as it occurs in the failure window, that is, after checking the Alarm A event flag but before the effective clear of the EXTI interrupt flag by hardware. The effective clear of the EXTI interrupt flag is delayed with respect to the software instruction to clear it.
