## STM32L471xx/475xx/476xx/486xx device errata

This document applies to the part numbers of STM32L471xx/475xx/476xx/486xx devices and the device variants as stated in this page.

It gives a summary and a description of the device errata, with respect to the device datasheet and reference manual RM0351.

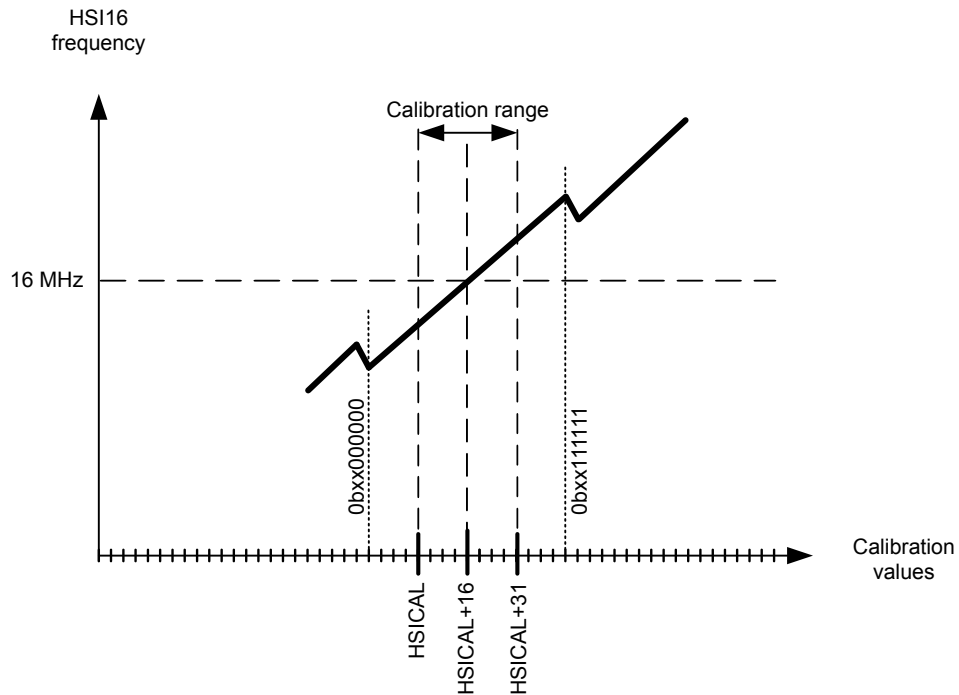
**Figure 1. HSI oscillator trimming characteristics**

Consequently, the user trim correction must not jump over the codes multiple of 64, which can limit the user correction either in positive or in the negative direction.

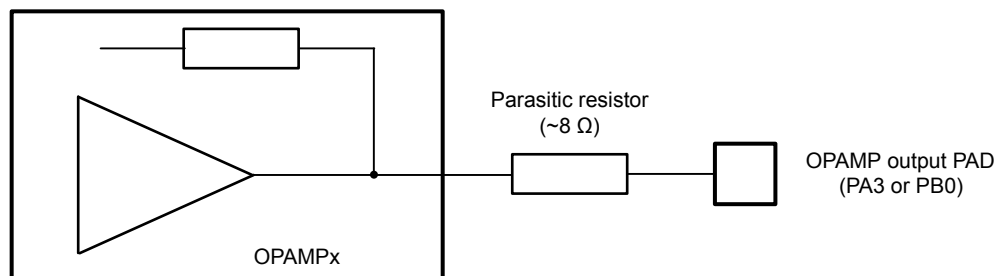
**Figure 2. Parasitic resistor on OPAMP output**

The value of the resistor between OPAMP outputs and I/O (PA3 or PB0) is greater than expected: 8  $\Omega$  typical, as shown in Figure 2. As a consequence, the OPAMP characteristics can be impacted depending on the current sunk on the output.

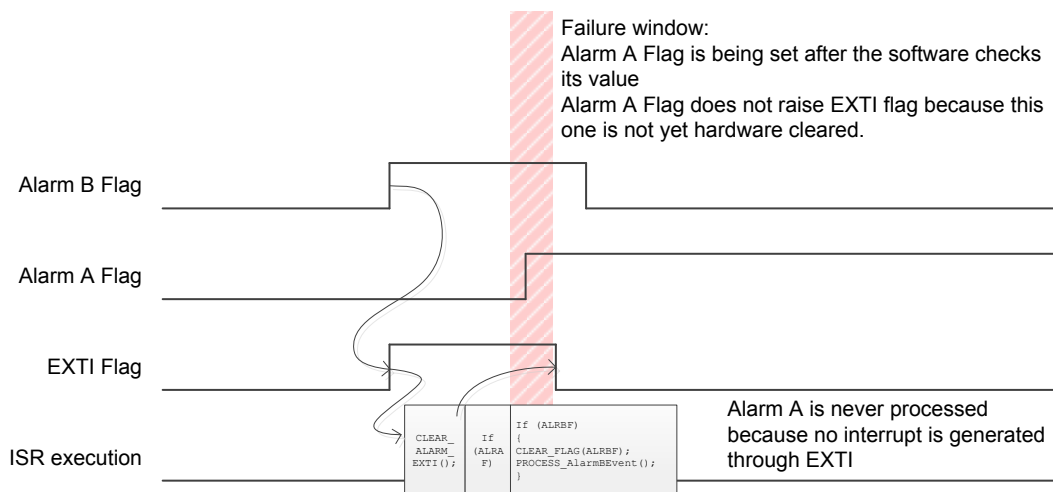
Figure 4. Masked RTC interrupt

The following code example and figure illustrate the failure mechanism: The Alarm A event is lost (fails to generate interrupt) as it occurs in the failure window, that is, after checking the Alarm A event flag but before the effective clear of the EXTI interrupt flag by hardware. The effective clear of the EXTI interrupt flag is delayed with respect to the software instruction to clear it.
