STM32L451xx/452xx/462xx device errata

This document applies to the part numbers of STM32L451xx/452xx/462xx devices and the device variants as stated in this page.

It gives a summary and a description of the device errata, with respect to the device datasheet and reference manual RM0394.

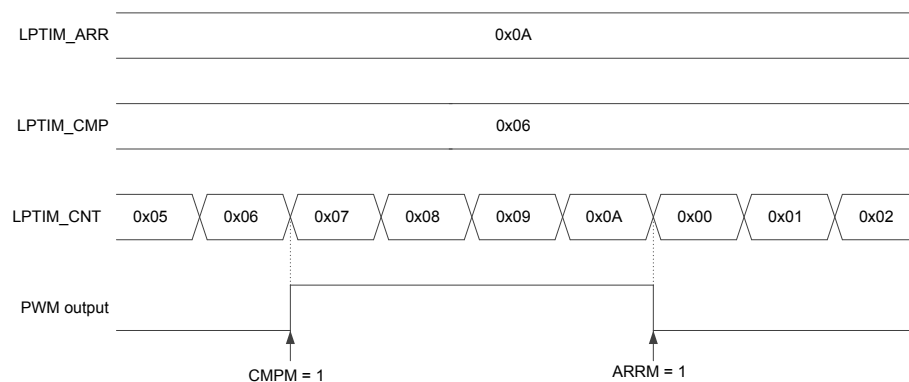
Figure 1. Example of PWM output mode

The following waveform gives the example of PWM output mode and the effect of the delay:

Workaround

Set the compare value to the desired value minus 1. For instance in order to generate a compare match when LPTM_CNT = 0x08, set the compare value to 0x07.
