## STM32L412xx/422xB device errata

This document applies to the part numbers of STM32L412xx/422xB devices and the device variants as stated in this page. It gives a summary and a description of the device errata, with respect to the device datasheet and reference manual RM0394. Deviation of the real device behavior from the intended device behavior is considered to be a device limitation. Deviation of the description in the reference manual or the datasheet from the intended device behavior is considered to be a documentation erratum. The term “*errata*” applies both to limitations and documentation errata.

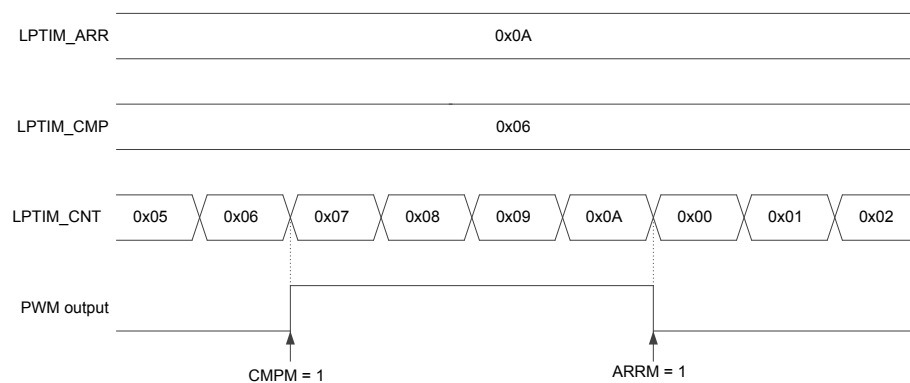
**Figure 1. Example of PWM output mode**

The following waveform gives the example of PWM output mode and the effect of the delay:

Set the compare value to the desired value minus 1. For instance in order to generate a compare match when LPTIM\_CNT = 0x08, set the compare value to 0x07.
