# ST25R3916 ST25R3917 ST25R3918 ST25R3920

Errata sheet

### ST25R3916, ST25R3917, ST25R3918, and ST25R3920 device limitations

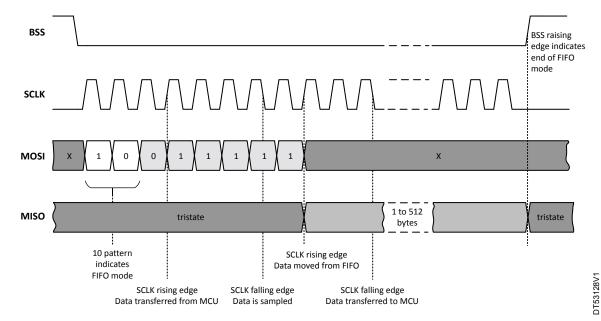
Figure 1. SPI communication: FIFO reading

During the read operation of the interrupt status register, under specific bit patterns of the MOSI line identified as X in Figure 1, the interrupt flags might not be valid, and the interrupt line stays high.
